## SITE PRACTICE AND TROUBLESHOOTING

# EXPANSIVE PARTICLES

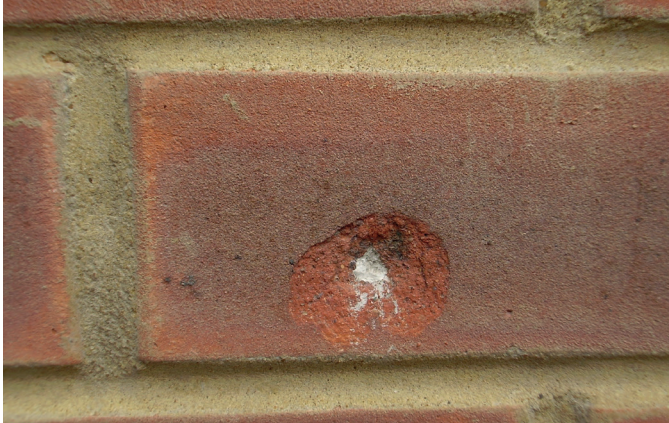
Expanded lime particle.

After firing, when the brick absorbs moisture, a chemical reaction takes place. The particles swell which, if close enough to the surface may cause portions of the brick face to “pop” off.

The results are small pits in the surface of the brick with a white (lime) or purple (siderite) spot in the centre.

This is not uncommon. It is strictly an aesthetic issue and will not affect the structural integrity of the brick. It is only the loss of a small portion of the surface of the brick and the exposure of the differing body colour underneath which causes concern.

The expanded particle is drilled out to provide a more substantial key for a filling material. The depression is then filled with a suitable material, such as a compound of a cementitious/resin nature, which is coloured to closely match the original brick colour and additions of various sands etc. are used to provide a similar texture.

The filler is then cured and if any further work is required to more closely resemble the brick surface this is then done. The whole surface of the brick including the filled area is then tinted to blend in with existing brickwork.
